# ASBESTOS MANAGEMENT PLAN

## Winsford Salt Mine

Version 3.0-2025

30/09/2025

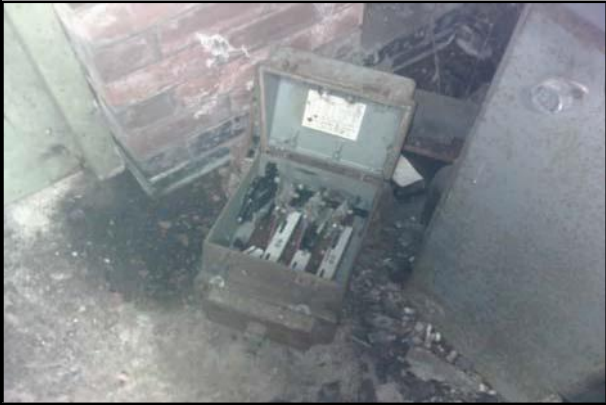
| Material Assessment Category: | | D | | Total Score (Material + Priority): | | 4 | | Risk Priority 1, 2 or 3: | | 3 | |
| | | | | <p>Notes:</p> <p>The sampled arc shields should be presumed to be present within switchgear throughout this substation.</p> <p>Recommendation:   Manage</p> | | | | | | | |

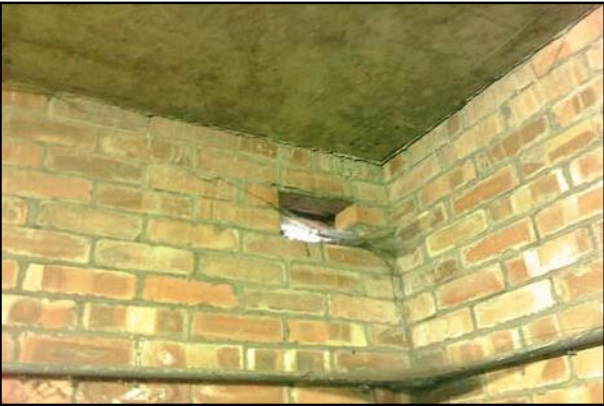
| Material Assessment Category: | | D | Total Score (Material + Priority): | 4 | Risk Priority 1, 2 or 3: | 3 | |
| | | | | Notes:<br>Airbrick shuttering throughout this building is either of the sampled material or natural slate. | | | |

| Recommendation: | | | | Manage | | | |

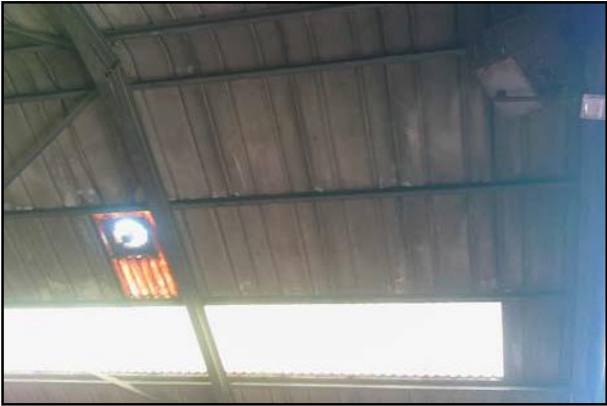
| Material Assessment Category: D | | Total Score (Material + Priority): 7 | | Risk Priority 1, 2 or 3: | | 3 | |
| | | | | <p>Notes:</p> <p>The sampled roof sheets are in a good but unsealed condition.</p> <p>Recommendation: Manage</p> | | | |

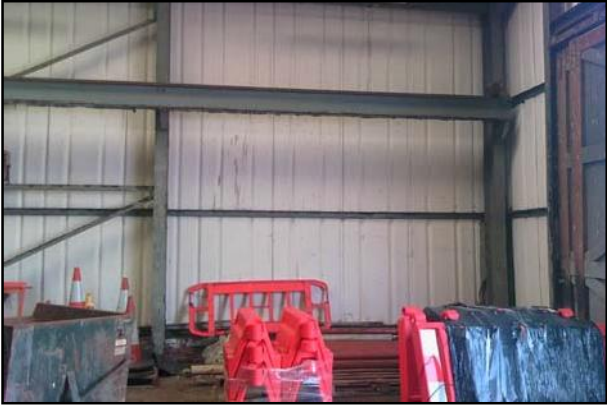
| | | | | Notes:<br>No inspection was undertaken within any crane or electrical equipment in this location | | | |

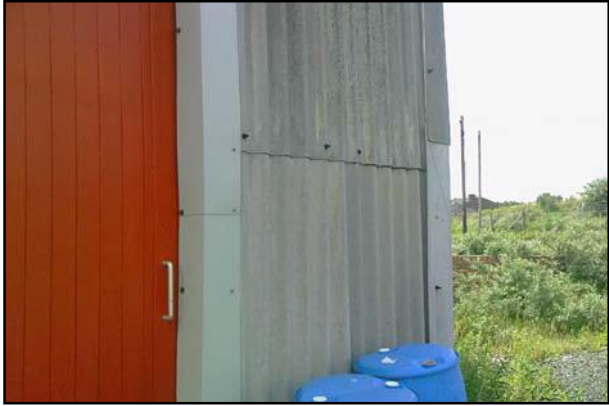
| Material Assessment Category: | | D | Total Score (Material + Priority): | 7 | Risk Priority 1, 2 or 3: | 3 |
| | | | | <p>Notes:</p> <p>An inspection within this building revealed unclad structural steelwork, uninsulated metal pipework, low level brick walls and Perspex skylights.</p> | | |

| | | | | Recommendation:    Manage | | |

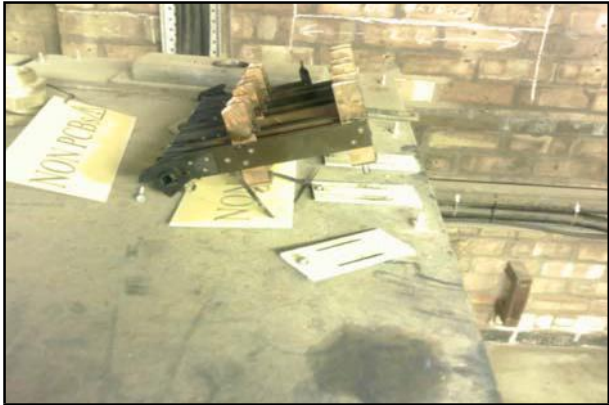
| | | | | Notes:<br>These arc shields are presumed to be present within electrical switchgear throughout this substation. | | | |

| | | | | Recommendation:    Remove | | | |

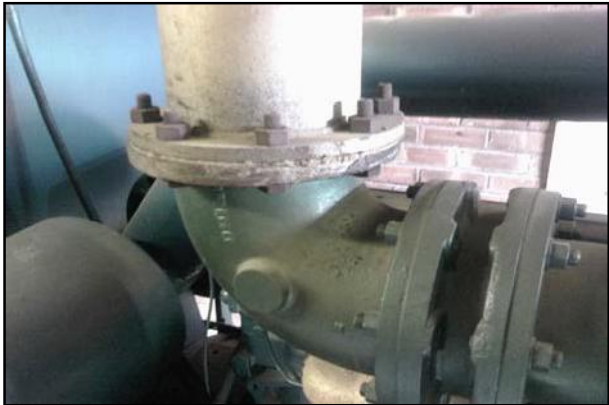
| | | | | Notes:<br>Further identical gaskets should be presumed to be present to pipework flanges throughout these substations. No inspection was undertaken within plant equipment throughout these substations for safety reasons. | | | |

| | | | | Recommendation:   Manage | | | |

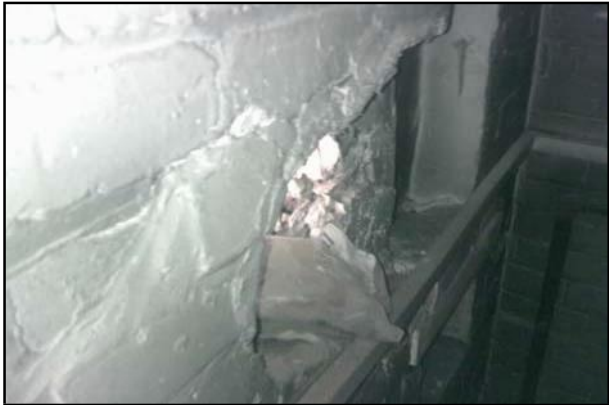
| Material Assessment Category: | | C | Total Score (Material + Priority): | | 8 | Risk Priority 1, 2 or 3: | | 3 |
| | | | | <p>Due to the sampled material serving no real purpose, removal is recommended.</p> | | | | |

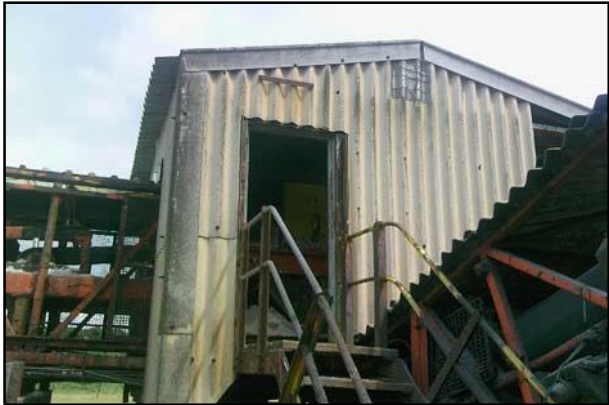
| Material Assessment Category: | | D | Total Score (Material + Priority): | | 8 | Risk Priority 1, 2 or 3: | | 3 |
| | | | | Notes:<br>An inspection within this conveyor motor room was limited due to the conveyor being in use at the time of the survey and therefore deemed unsafe | | | | |

| | | | | Recommendation:    Manage | | | | |

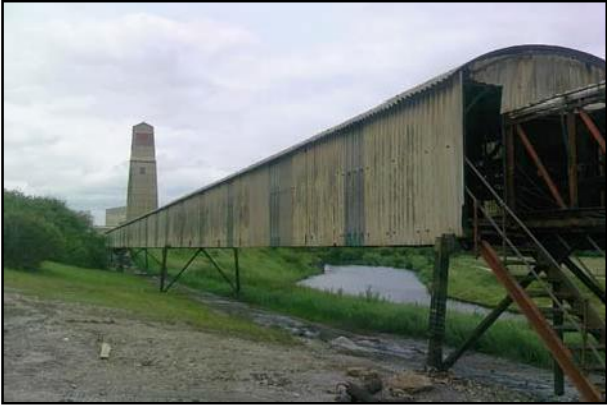
| | | | | <p>All Safecoat conveyor tunnel corrugated wall and roof sheets are of an identical material to that sampled. A modern conveyor tunnel is present which appears to be of profiled metal construction. No inspection was undertaken within these conveyor tunnels due to the conveyor being in use at the time of the survey and therefore deemed unsafe.</p> | | | |

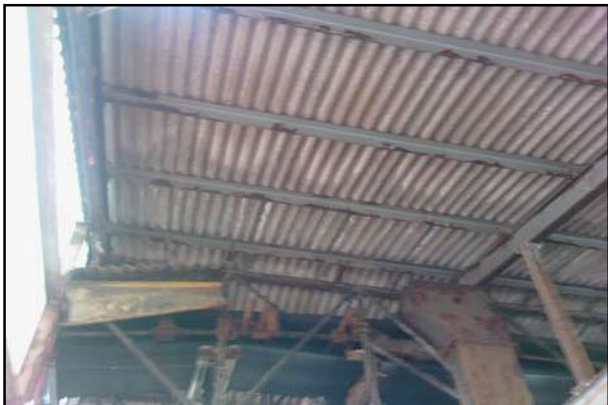
| | | | | <p>An inspection within the Safecoat barn was not possible due to large stockpiles of loose salt being present causing a safety hazard. Walls are of profiled plastic.</p> | | | |

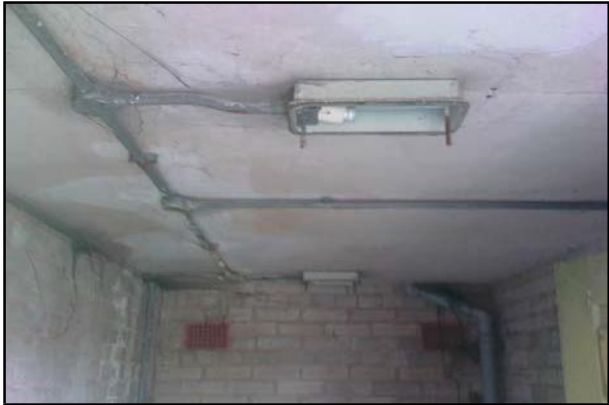
| Material Assessment Category: | | B | Total Score (Material + Priority): | 11 | Risk Priority 1, 2 or 3: | | 3 |
| | | | | <p>The sampled panels are in a good but unsealed condition therefore encapsulation is recommended.</p> | | | |

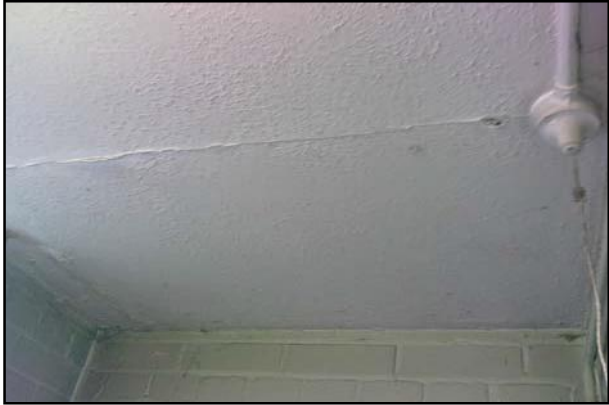
| | | | | <p>The textured coating is applied to a plasterboard ceiling. The toilet cistern is plastic.</p> | | | |

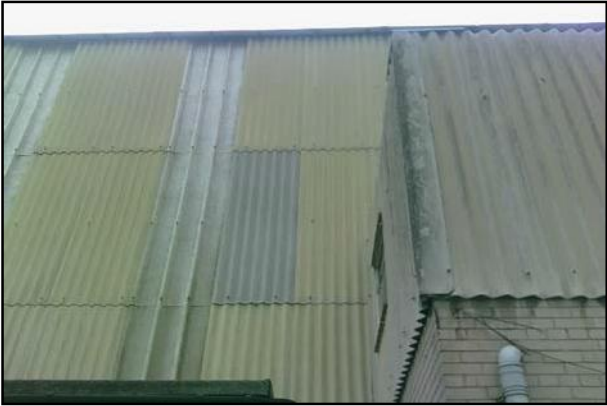
| Material Assessment Category: | | D | Total Score (Material + Priority): | | 4 | Risk Priority 1, 2 or 3: | | 3 |
| | | | | <p>Notes:</p> <p>All cladding panels to this building are of an identical material to that sampled.</p> <p>Recommendation:   Manage</p> | | | | |

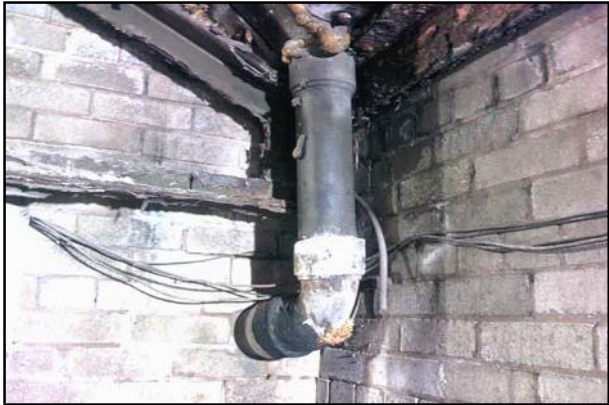
| Building ID | Compass Minerals | | | Item Location | Downpipe to rear wall | | |

| | | | | Identical downpipes were noted to the left hand side elevation. | | | |

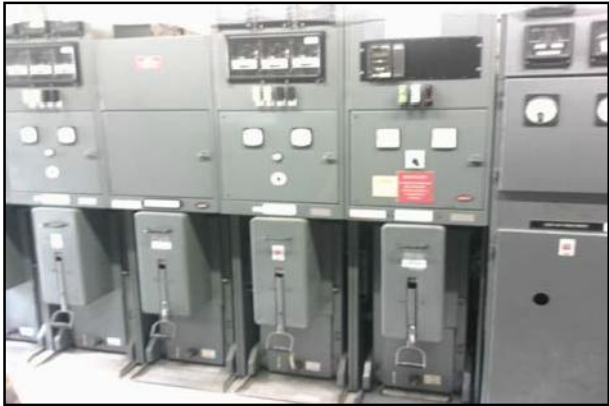
| | | | | <p>Notes:</p> <p>No inspection was undertaken within the electrical switchgear for safety reasons therefore asbestos containing materials should be presumed to be present until proven otherwise.</p> | | | |

| | | | | <p>Recommendation:   Manage</p> | | | |

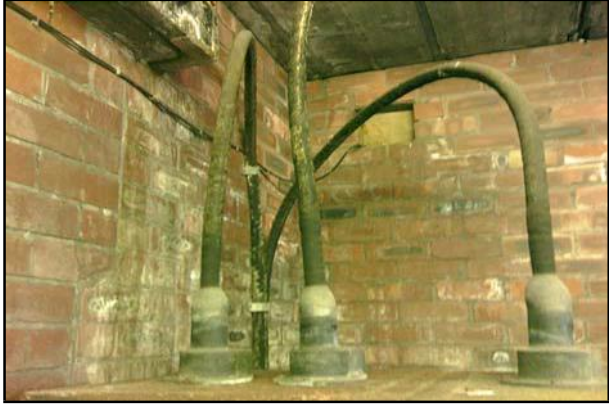
| | | | | Notes:<br><br>No inspection was undertaken within high voltage cable troughs for safety reasons. No sample of the woven cable wrap was taken for safety reasons. | | | |

| | | | | Recommendation:    Manage | | | |

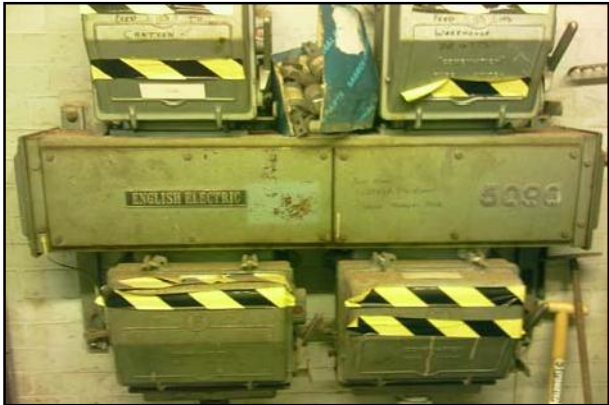
| | | | | <p>Notes:</p> <p>No inspection was undertaken within the electrical switchgear throughout this building therefore asbestos containing materials should be presumed to be present until proven otherwise.</p> | | | |

| | | | | Recommendation: Manage | | | |

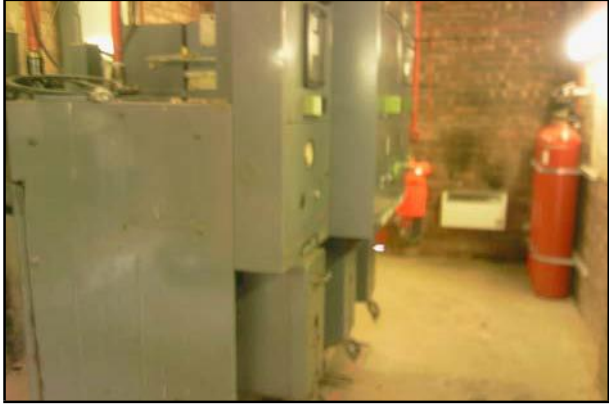
| | | | | Notes:<br><br>No inspection was undertaken within the electrical switchgear for safety reasons therefore asbestos containing materials should be presumed to be present until proven otherwise. No inspection was undertaken within the high voltage cable troughs for safety reasons. Identical switchgear is present within Substation 92. | | | |

| | | | | Recommendation:    Manage | | | |

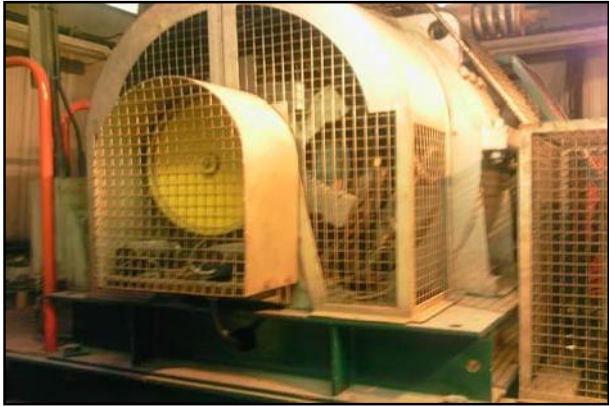
| | | | | Notes:<br>An inspection within this mine shaft lift motor room revealed metal cladding to the walls, unclad structural steelwork and metal floors. Inspection within this motor room was very limited due to the large number of hazards. | | | |

| | | | | Recommendation:    Manage | | | |

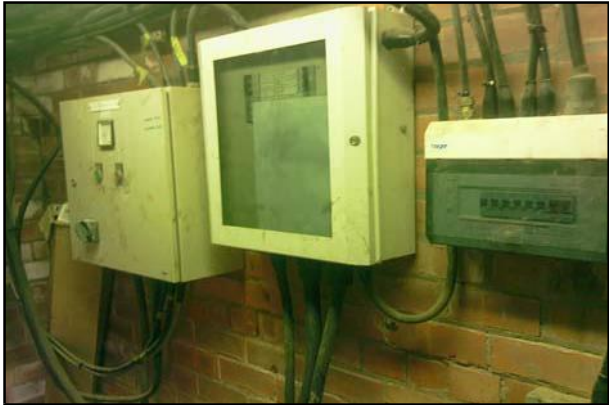
| | | | | No inspection was undertaken within the electrical switchgear therefore asbestos containing materials should be presumed to be present until proven otherwise. | | | |

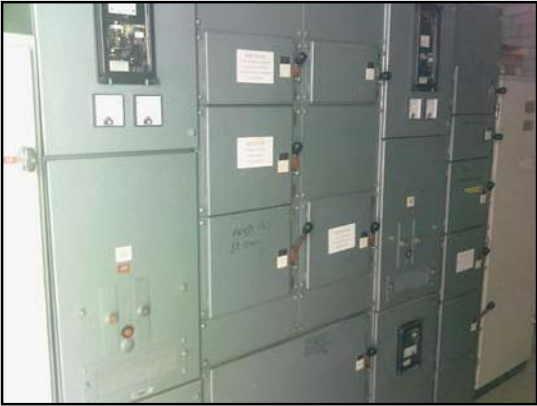
| | | | | Notes:<br>No inspection was undertaken within the electrical switchgear therefore asbestos containing materials should be presumed to be present until proven otherwise. No inspection was undertaken within the high voltage cable troughs for safety reasons. | | | | |

| | | | | Recommendation:    Manage | | | | |

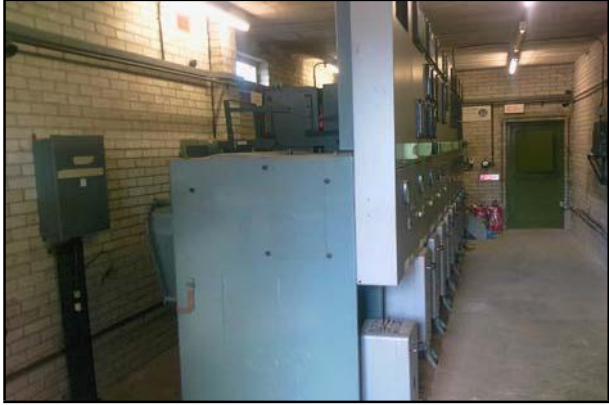
| | | | | Notes:<br>No inspection was undertaken within the electrical switchgear therefore asbestos containing materials should be presumed to be present until proven otherwise. No inspection was undertaken within the high voltage cable troughs for safety reasons. | | | |

| | | | | Recommendation:    Manage | | | |

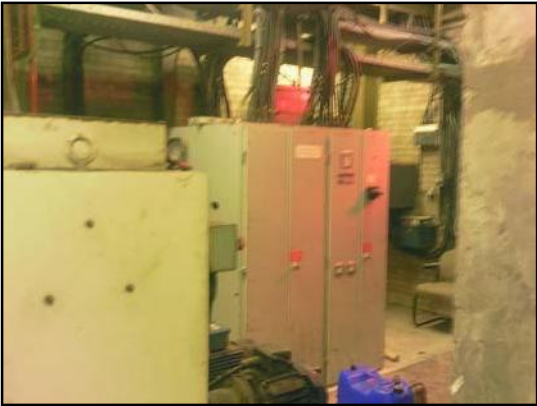
| | | | | Notes:<br><br>No inspection was undertaken within the electrical switchgear throughout this building therefore asbestos containing materials should be presumed to be present until proven otherwise. | | | |

| | | | | Recommendation:    Manage | | | |

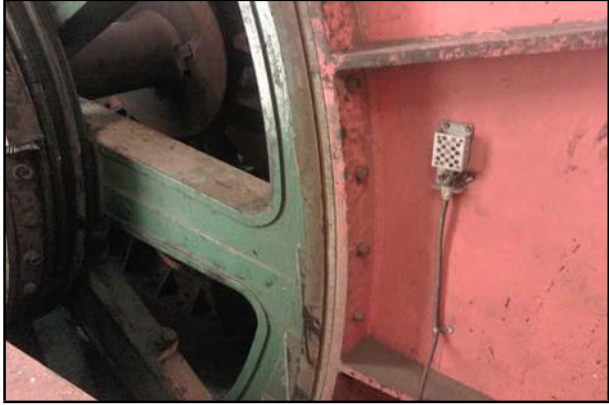
| | | | | Notes:<br>No inspection of this winding machine was possible due to being in use at the time of the survey therefore it must be presumed to contain asbestos until proven otherwise. An inspection within the first floor winding room revealed plasterboard wall and ceiling panels, low level brick walls and large plant and electrical equipment. No inspection was undertaken within the plant and electrical equipment for safety reasons. | | | | |

| | | | | Recommendation:    Manage | | | | |

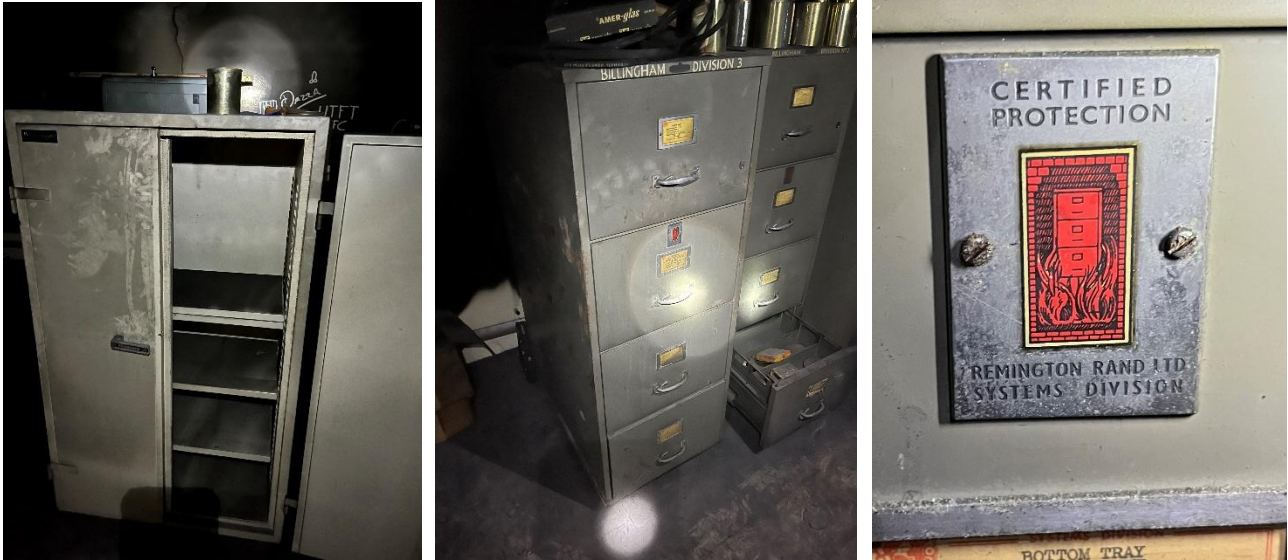
The old canning building has within it, asbestos lined filling cabinets and strong boxes.

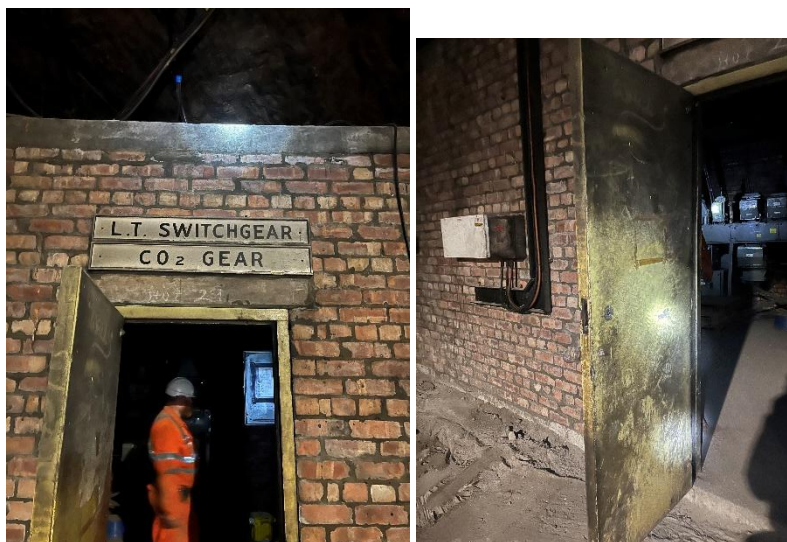
Door lined with asbestos cement.

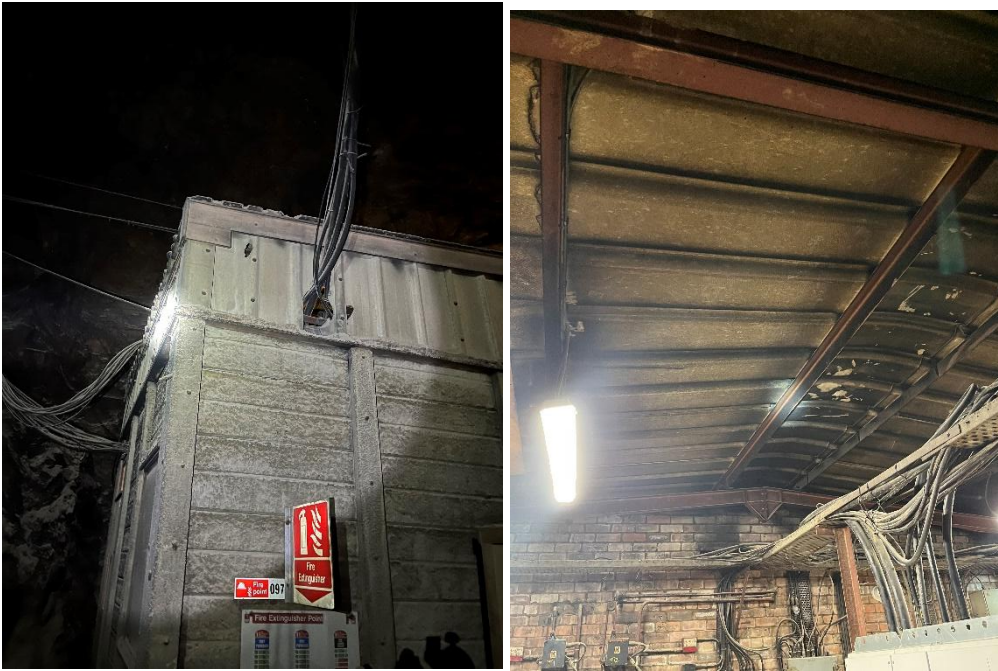
## Asbestos cement roofing to Substations

All of ACMs located within the mine works are of low to medium risk.
