# ASBESTOS MANAGEMENT PLAN

## Winsford Salt Mine

Version 3.0-2025

30/09/2025

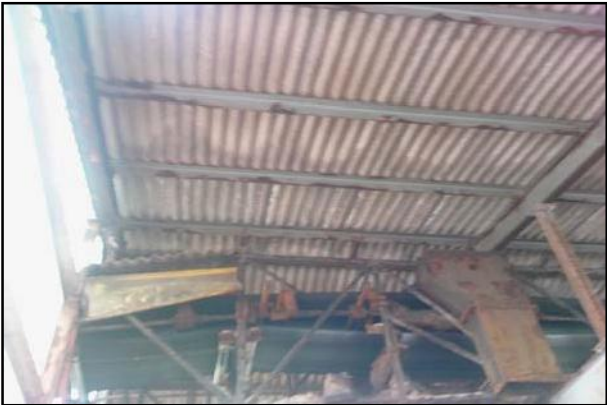
The extent given reflects the area surrounding location 89 where the sampled material is present. Debris of an identical material to that sampled is common to various areas throughout this site.

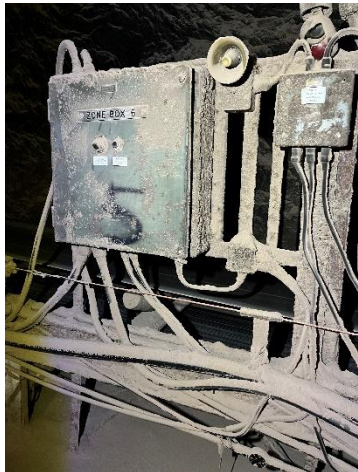
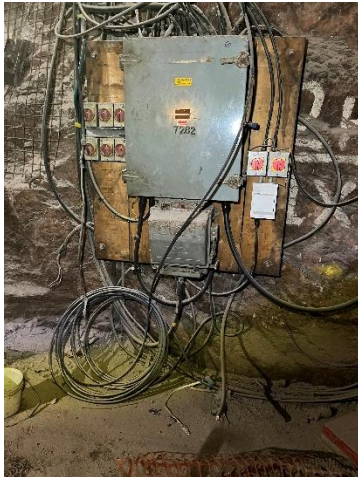
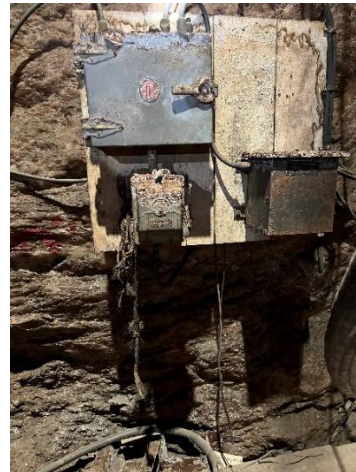
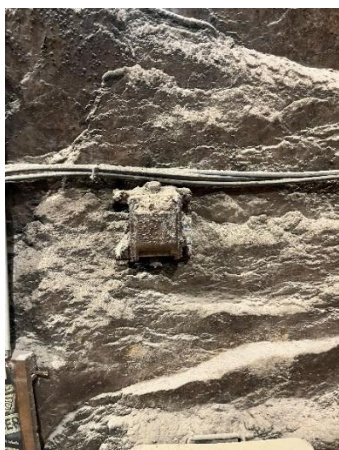
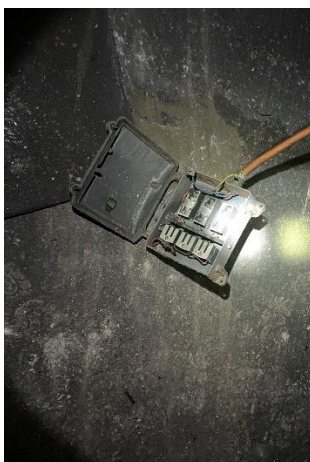
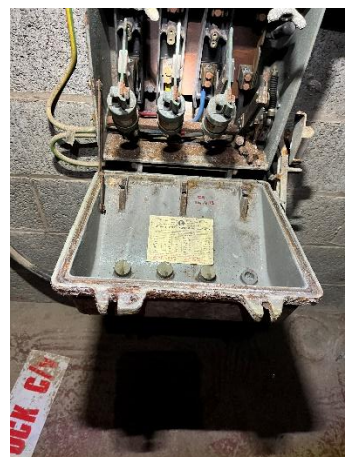
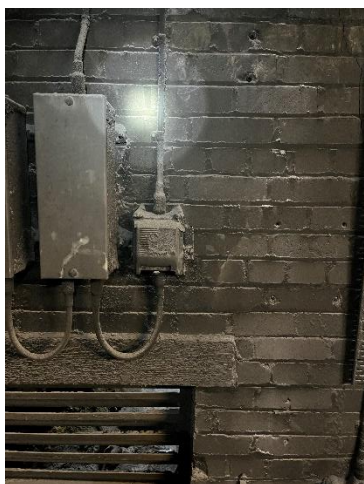
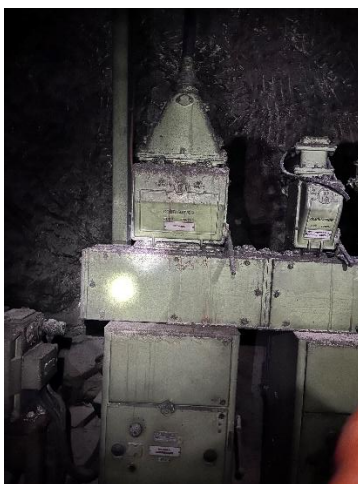
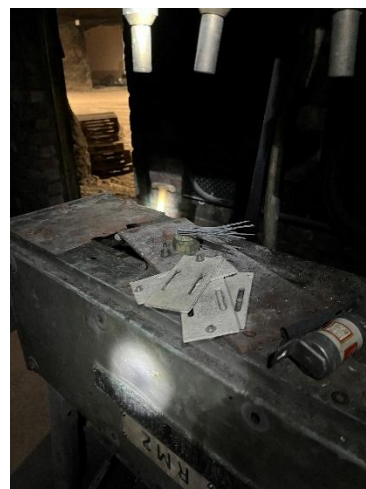
Asbestos containing materials (ACMa) are located throughout the mine workings.

The main ACMs are mechanical and electrical components and assets. These are so numerous and their location so widespread and varied.

The following images are a representation of these assets:

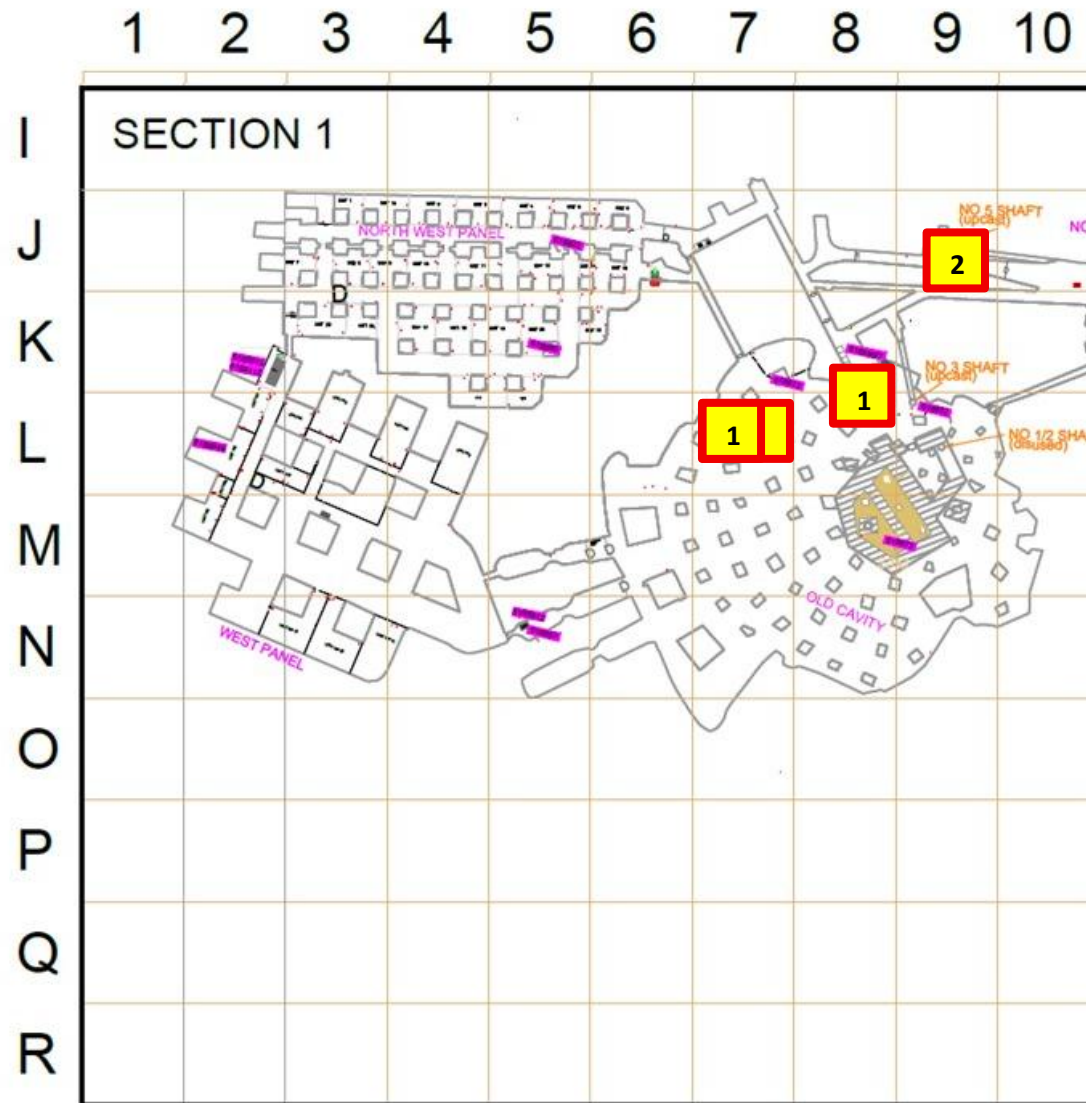
In the former canning building and in several substations throughout this section

Aged electrical assets have also been proven to contain asbestos.

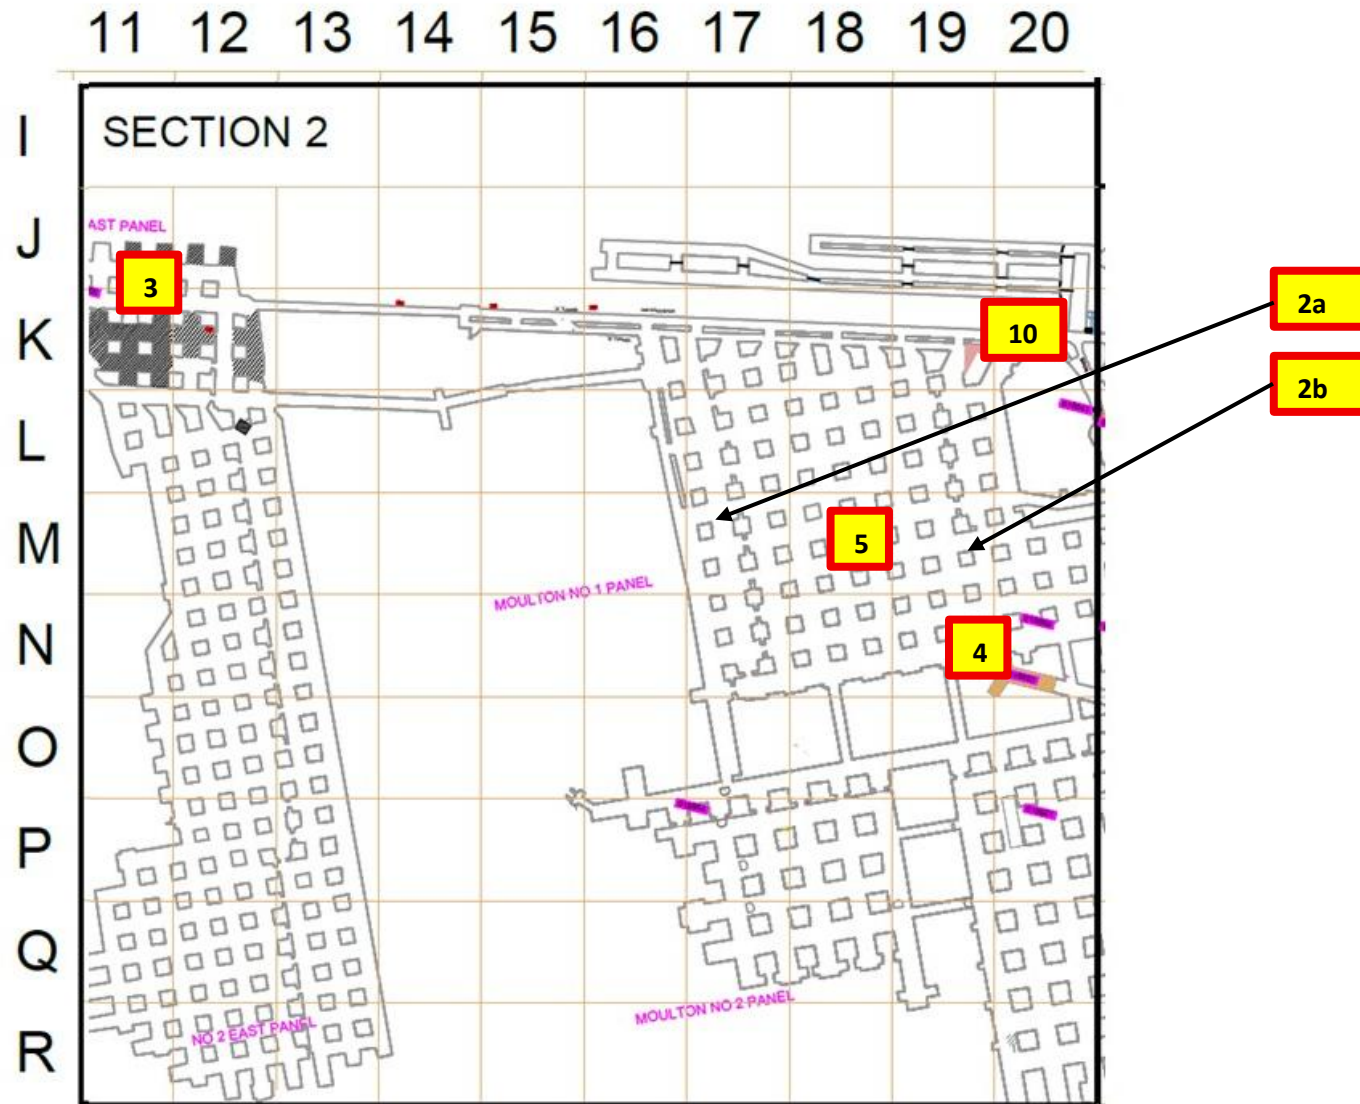
### 1.2 Mine Section 2

Asbestos has been identified throughout this section in and particularly the substations and within/on aged electrical assets

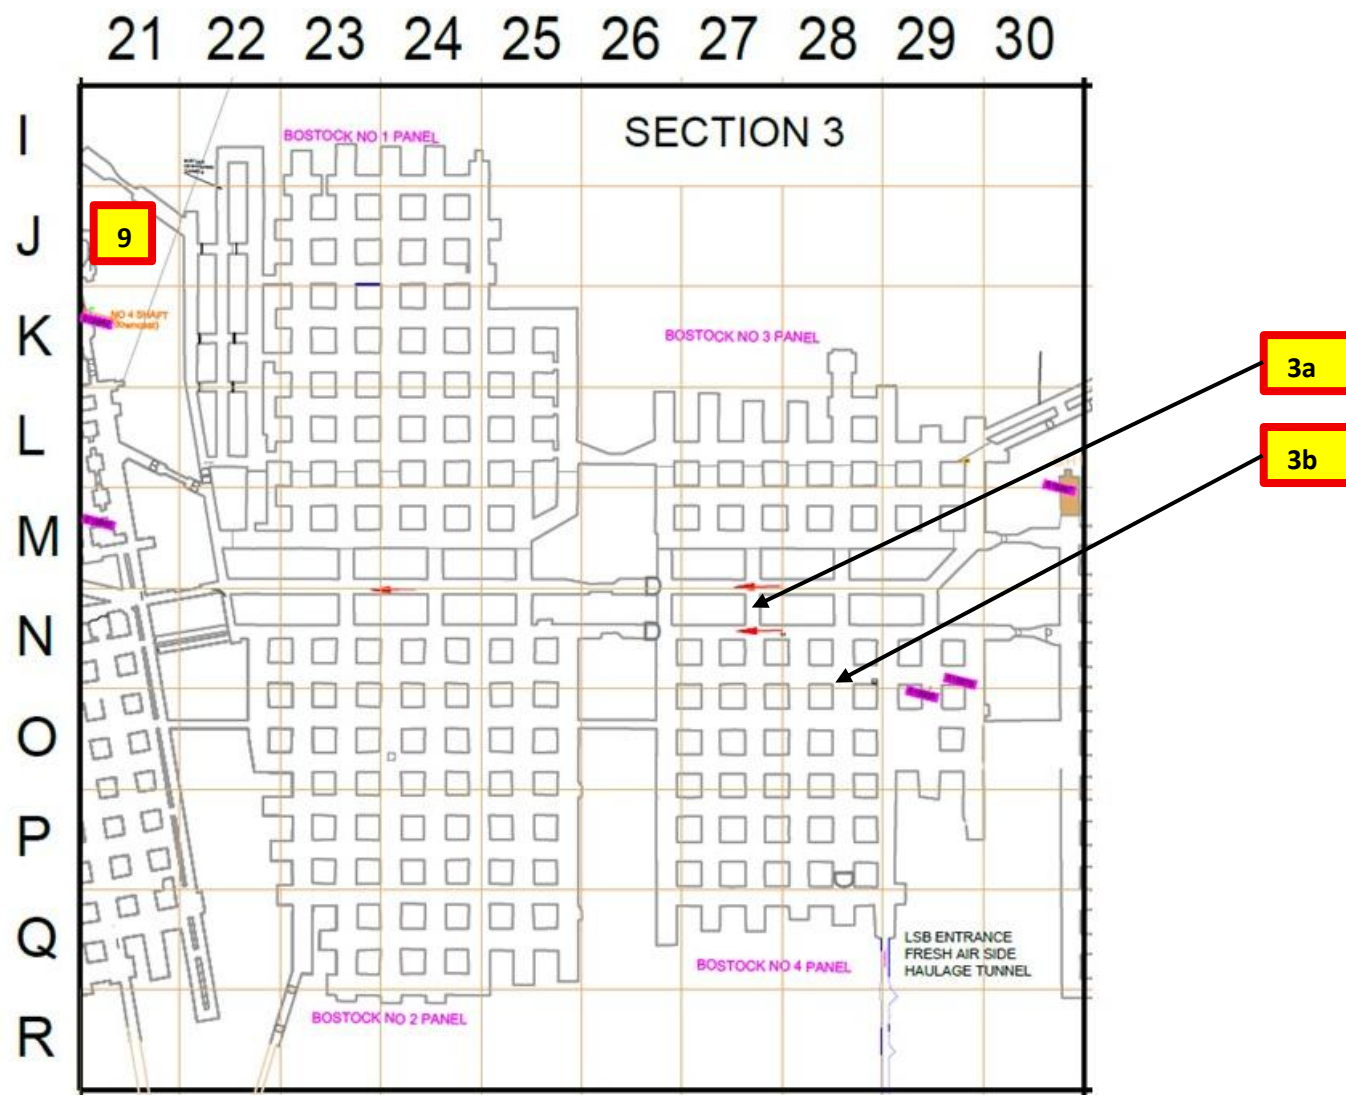
### 1.3 Mine Section 3

Asbestos has been identified throughout this section in and particularly the substations and within/on aged electrical assets

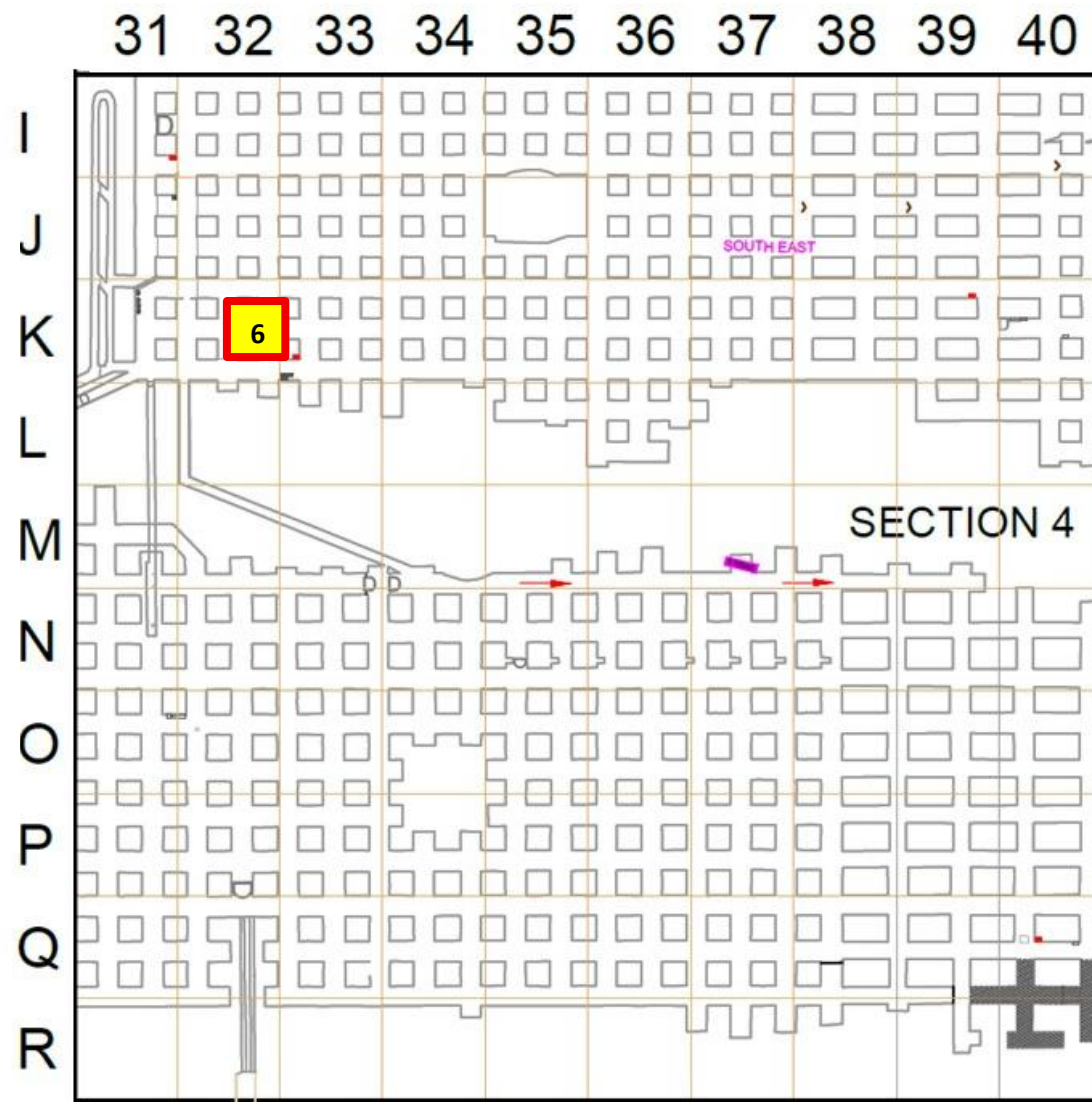
#### 1.4 Mine Section 4

Asbestos has been identified throughout this section in and particularly the substations and within/on aged electrical assets

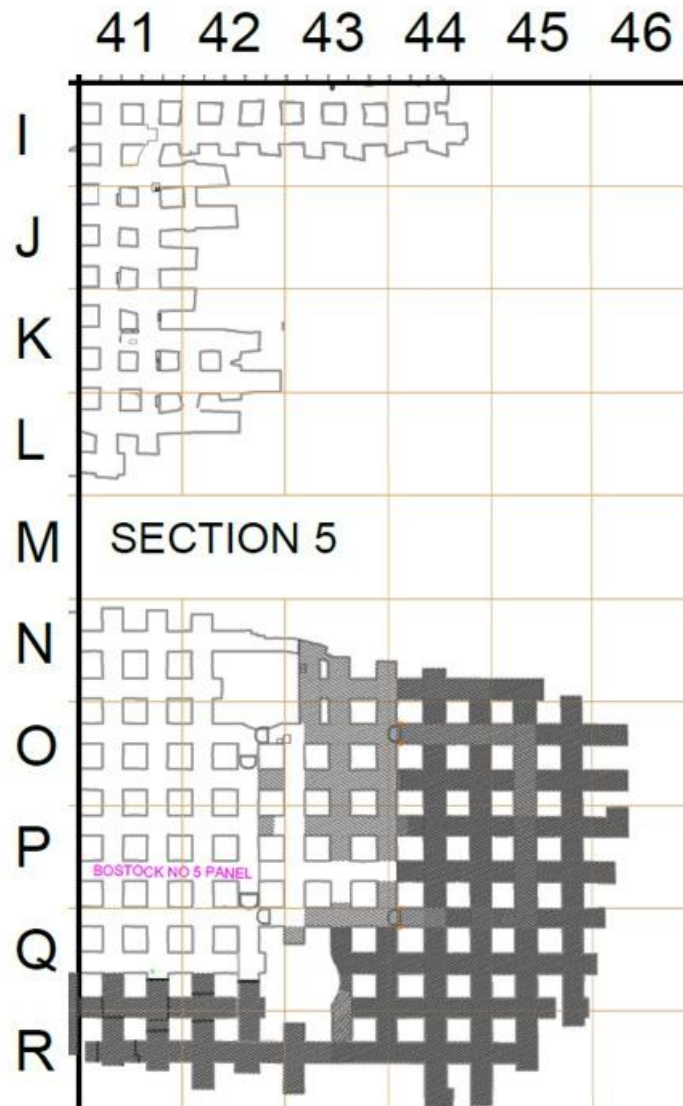
### 1.5 Section 5

Asbestos has been identified throughout this section in and particularly the substations and within/on aged electrical assets

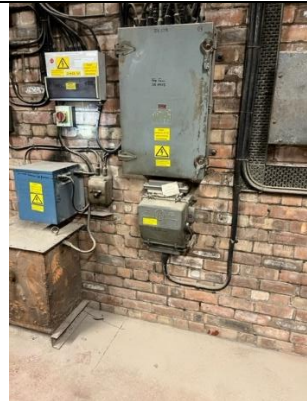
| Location | Map section | Description | Asbestos present | Action | |
|---|---|---|---|---|---|
| 4 | 2 | Sheeps Bridge Sub<br><br>Electrical isolators | Yes<br><br>Strongly presumed<br>due to being live | Monitor | |

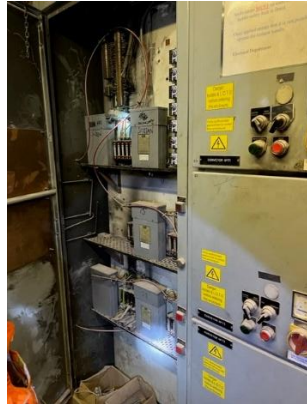
| Location | Map section | Description | Asbestos present | Action | |
|---|---|---|---|---|---|
| 5 | 2 | GEC SUB | Yes | Monitor | |

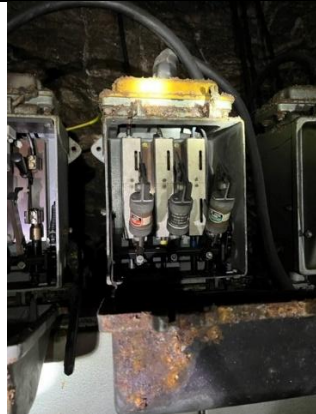
| 1a | 1 | Electrical isolator | Yes | Monitor | |

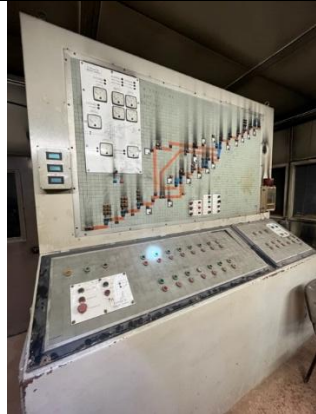
| 2a | 2 | Electrical control panel | Yes<br>Strongly presumed<br>due to being live | Monitor | |

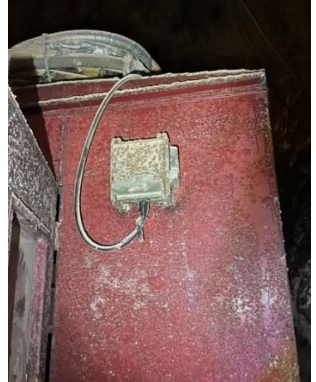
| 2b | 2 | Electrical isolator | Yes<br>Strongly presumed<br>due to being live | Monitor | |

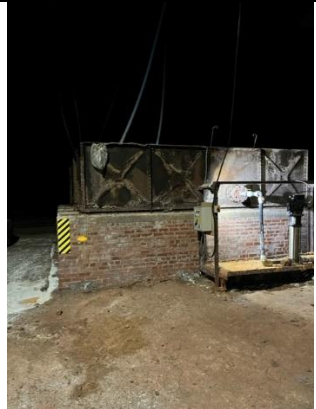
| 3a | 3 | Gaskets in pipework flanges | Yes<br>Strongly presumed | Monitor | |

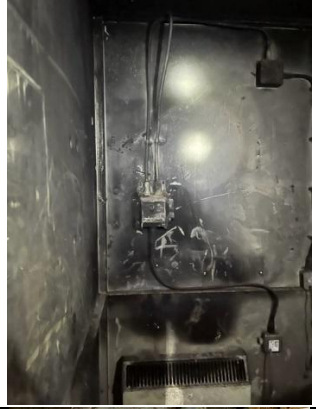
| 3b | 3 | Electrical isolators | Yes<br>Strongly presumed<br>due to being live | Monitor | |

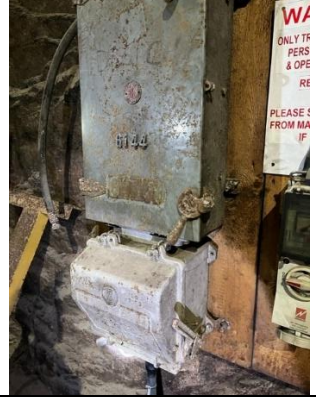
| 3c | 3 | Electrical isolator | Yes<br>Strongly presumed<br>due to being live | Monitor | |
